DEPARTMENT OF TRANSPORTATION

Quality Assurance and Source Inspection

Contract #: 04-0120F4Cty: SF/ALA Rte: 80 PM: 13.2/13.9File #: 69.28**WELDING INSPECTION REPORT****Resident Engineer:**Siegenthaler, Peter**Address:** 333 Burma Road**City:** Oakland, CA 94607**Report No:** WIR-019525**Date Inspected:** 25-Jan-2011**Project Name:** SAS Superstructure**OSM Arrival Time:** 700**Prime Contractor:** American Bridge/Fluor Enterprises, a JV**OSM Departure Time:** 1900**Contractor:** Zhenhua Port Machinery Company, Ltd (ZPMC), Changxing Island **Location:** Shanghai, China**CWI Name:** Qiu Wen.**CWI Present:** Yes No**Inspected CWI report:** Yes No N/A**Rod Oven in Use:** Yes No N/A**Electrode to specification:** Yes No N/A**Weld Procedures Followed:** Yes No N/A**Qualified Welders:** Yes No N/A**Verified Joint Fit-up:** Yes No N/A**Approved Drawings:** Yes No N/A**Approved WPS:** Yes No N/A**Delayed / Cancelled:** Yes No N/A**Bridge No:** 34-0006**Component:** OBG components.**Summary of Items Observed:**

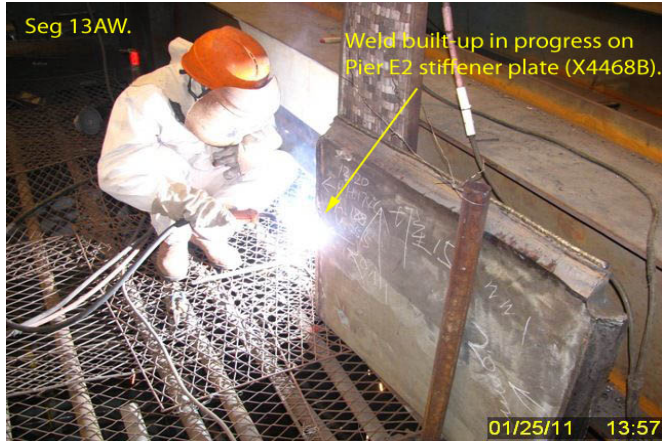
Repair welding / weld built up on Pier E2 stiffener plate (X4468B). The welder is identified as 067876 and was

observed welding in the 3G position. Welding process was identified as Flux Cored Arc Welding (FCAW). ZPMC QC was identified as Mr. Qiu Wen. The welding variables recorded by this QC appeared to comply with WPS: 345-FCAW-3G(3F)-ESAB-Repair. Repair welding was done as per Welding Repair Report (WRR): B-WR 20065 Rev-0. See attached photo for further information.
